# **Navajo Abandoned Uranium Mine**

## **Site Screen Report**

### **Tse079 AUM Site**

**August 2010**

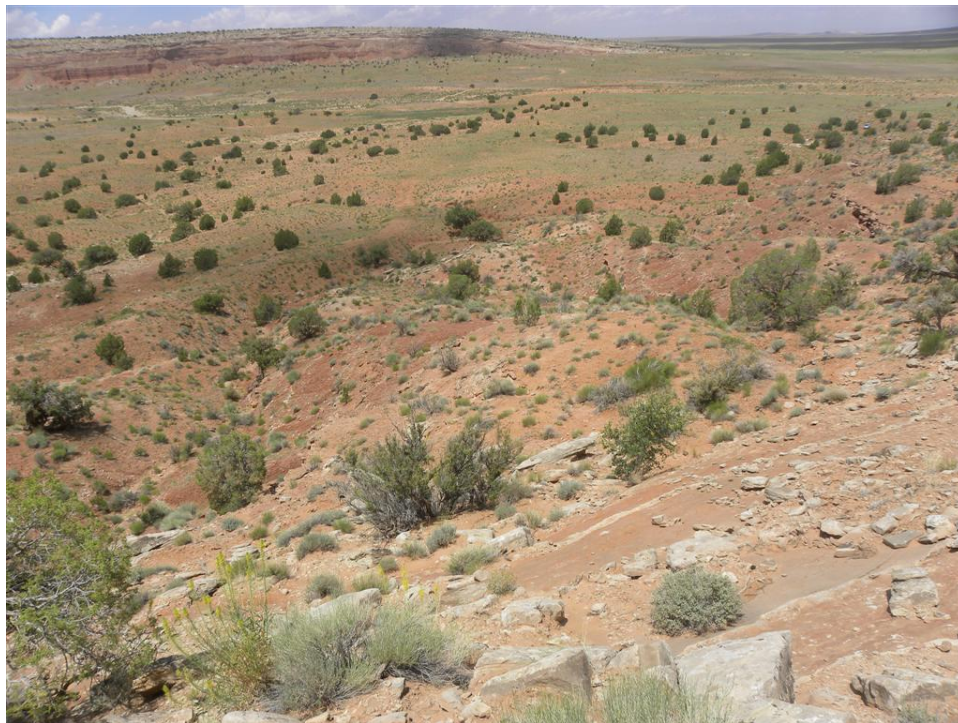
Photo 1. Tse079 site

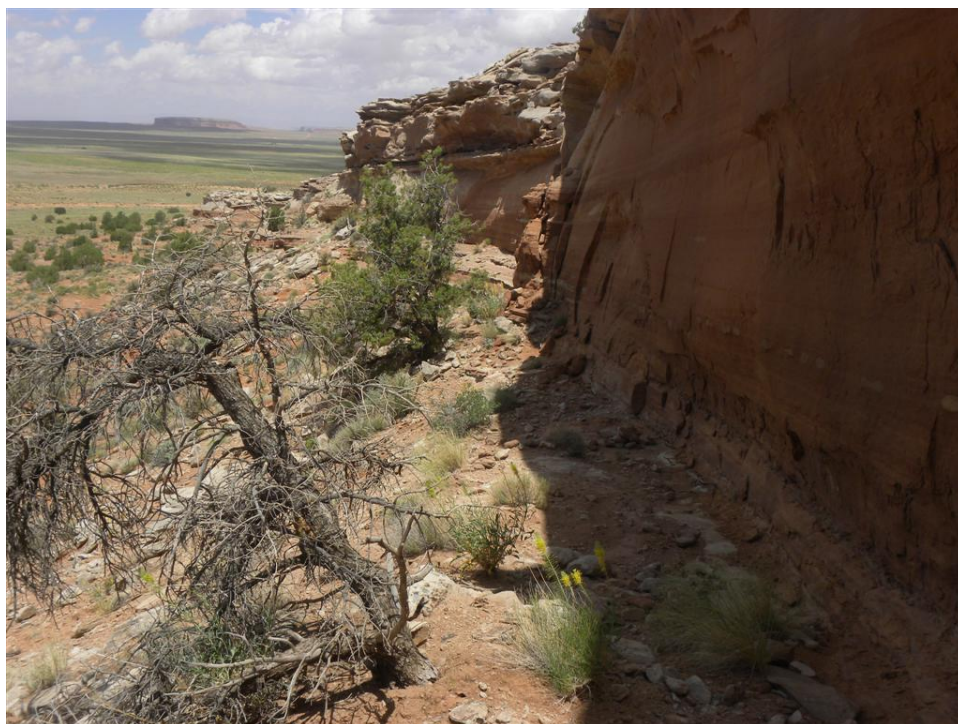
Photo 2. Tse079 site
